MICROSCOPIC INVESTIGATION OF INTERFACE  
CORROSION OF STEEL-ALUMINUM EXPLOSIVELY  
BONDED MATERIAL EXPOSED TO  
PERIODIC SEA WATER SPRAY

# THESIS

September 1976

in the laboratory to simulate in-service conditions with joint specimens receiving exposures of varying durations. A corrosion model is hypothesized and photomicrographs of the various exposed specimens are presented and discussed.

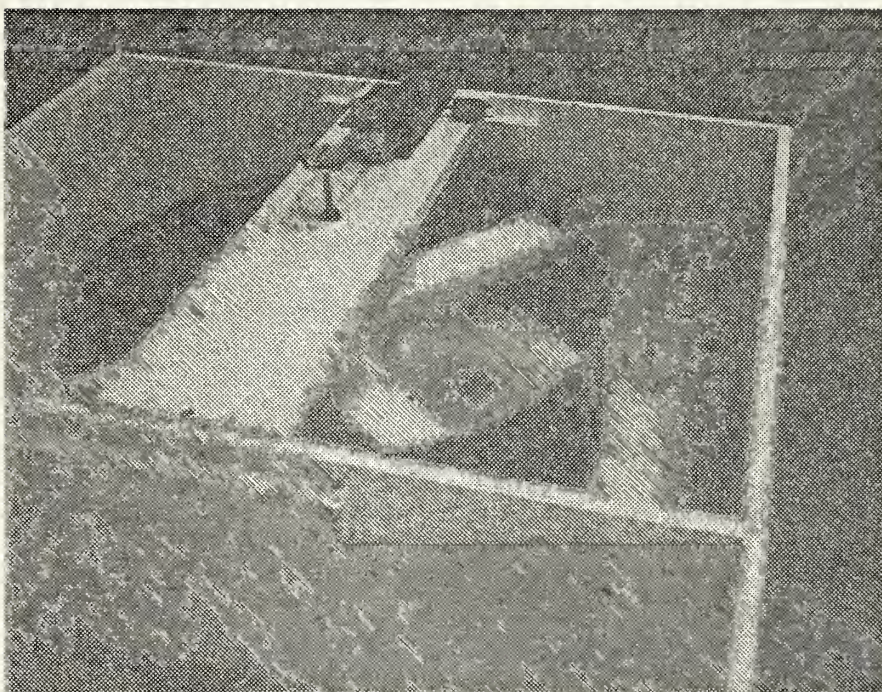
Figure 15. Rim assembly and nozzle installed in chamber.

Each chamber of the test tank also contained a spray nozzle mechanism. The nozzle assembly extended from the bottom of the tank and sprayed continuously as the samples rotated by it. The nozzles were designed to minimize the direct impingement velocity of the spray mist on the samples. A single stream of sea water at very low pressure exited from the center of the nozzle while two jets of air, at 3 to 5 psi, were directed at 45° angles.

The net effect of this design was to flatten out the water stream and create a fine vertical line of mist much like that provided by a normal spray painting gun. Figure 15 shows a rim assembly installed in its chamber with a nozzle assembly in the upper right chamber corner.

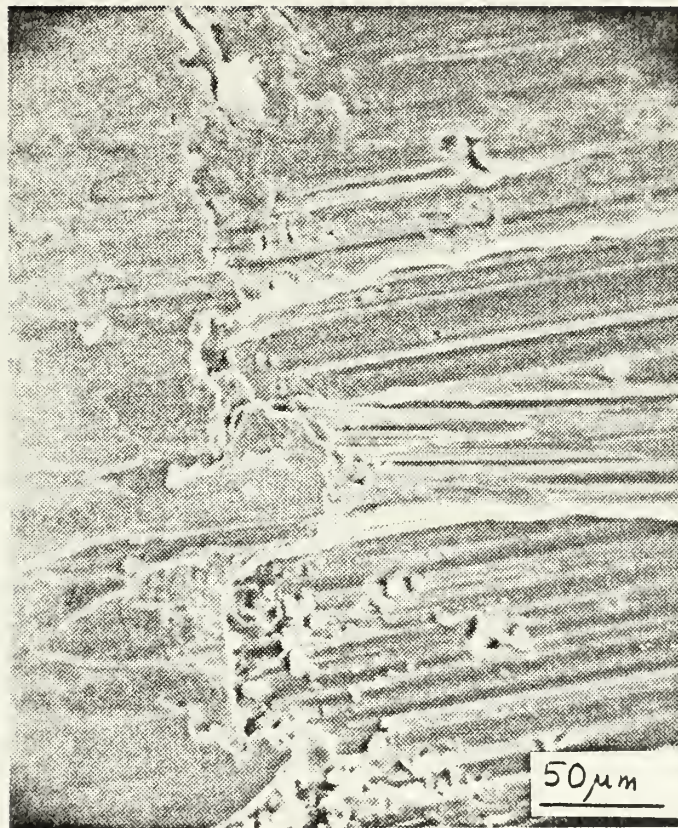
Figure 21. 320x SEM photograph of steel-aluminum interface in the as-sanded condition (Steel $\longleftrightarrow$ Al).

The standard test samples were finished with #50 grit sandpaper. Figure 21 shows the interface running vertically, with the aluminum on the right. The surface appearance is characteristic of all samples in their unexposed state. Sanding was accomplished from left to right and was intended to be as nearly perpendicular to the overall interface plane as possible. In the center right of the picture, some sanding grooves tend to cover other grooves. This feature becomes more difficult to distinguish farther away from the interface and at higher magnifications. The aluminum is obviously much more deeply grooved than the steel and appears to be somewhat recessed from the level of the steel. Both of these features are quite reasonable, given that 1100 aluminum is a much more malleable metal. Particles of the worked metal and sanding material can be seen at the interface. The surface profile seen may be very distinct; but since the bonded joints are truly three-dimensional, a completely different profile might reasonably exist at a relatively short distance into the metal. Therefore care must be exercised before attributing an apparent undercutting of one bond face surface or another to a corrosion process.

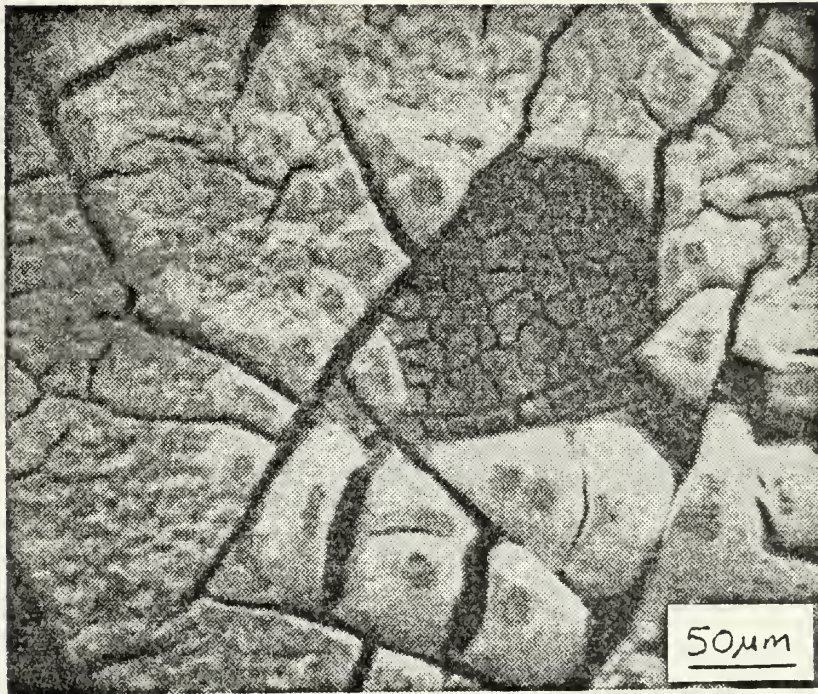
Figure 63. 280x SEM picture of alumina layer beneath second corrosion product film on five-week exposure sample (Steel surface).
